3. Existing Buildings

Existing Building Assessment

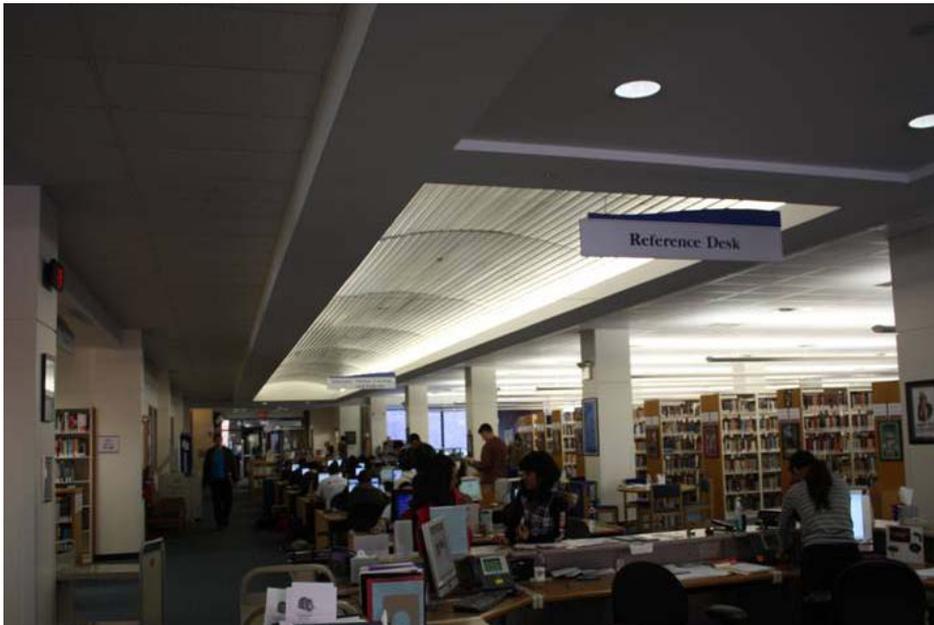
Building F houses the college library on the first and second floors and a variety of student services and programs on the third floor. The current college library offers an antiquated program of spaces more oriented toward space for books than space for people and technology. The library is too small for the current student population, which results in overcrowded conditions and intense demands on the building systems like electrical wiring and HVAC.

The programs on the third floor are also undersized, but their primary deficiency is that the location is very difficult to find and access.

HVAC, electrical, and plumbing upgrades, as well as to windows and doors are recommended.

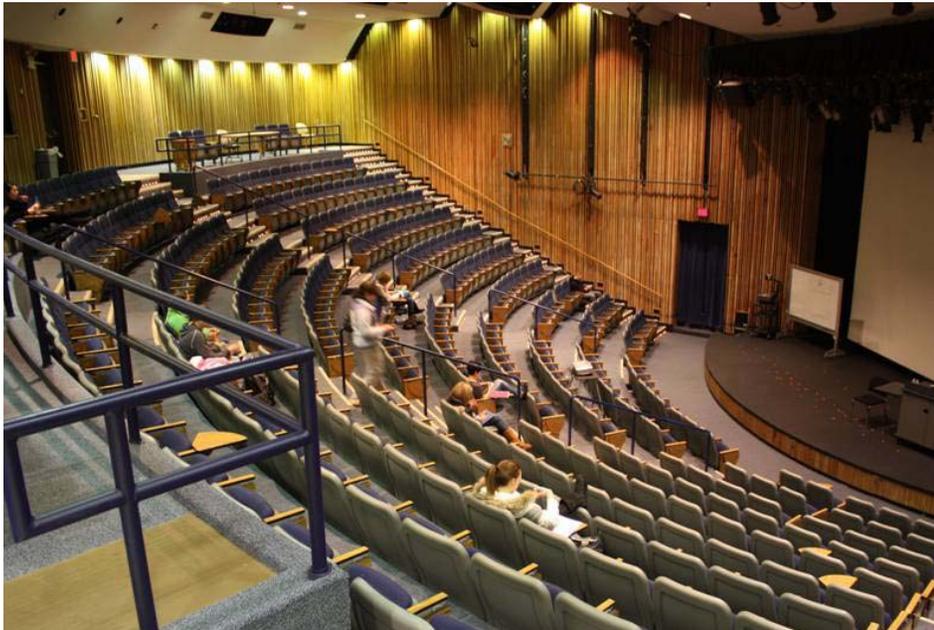
Building J

The building is in generally good condition and most of the rooms serve their purpose well. A few of the classrooms have been converted from other uses and provide layout and access difficulties.

The HVAC, electrical, and plumbing systems are all original and will soon need work. The electrical distribution has been upgraded for the computer labs but more outlets are required. Temperature control and lighting is dated.

This building specifically suffers from the lack of student study areas, which produce conflicts in corridors and noise

control issues for the classrooms.

The theater is in need of upgrading and additional space for stage support.

The existing windows and doors should be replaced with thermally efficient and better functioning devices.

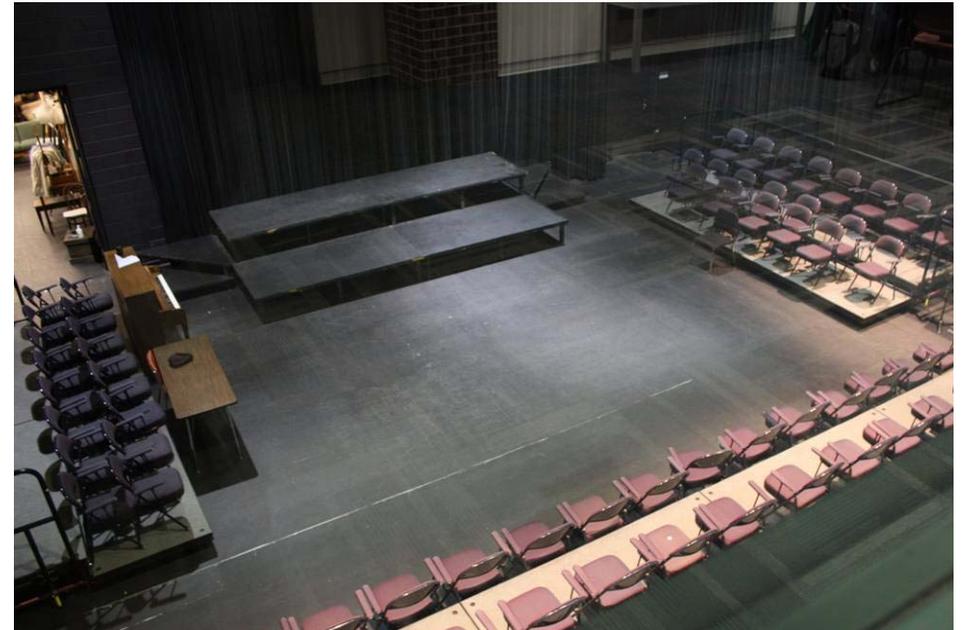
Building L

This building has some of the best general use classrooms on the campus. There are a few converted rooms that should be modified for better function. The bookstore is small and lacks storage

The HVAC, electrical, and plumbing systems are mostly original and will soon need work. Renovated areas have been upgraded. The electrical distribution has had some upgrades but more outlets are required. Temp control and lighting is dated.

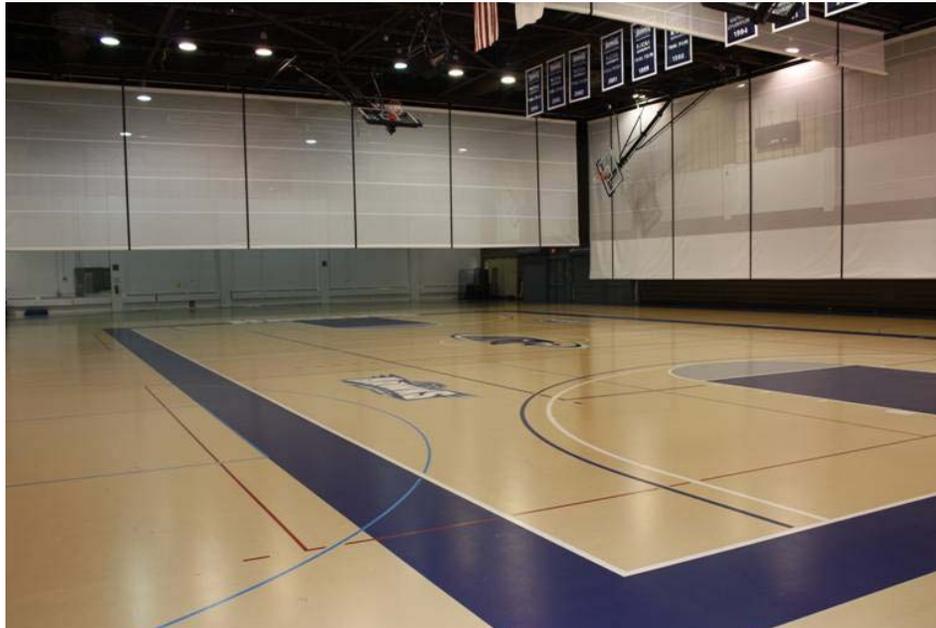
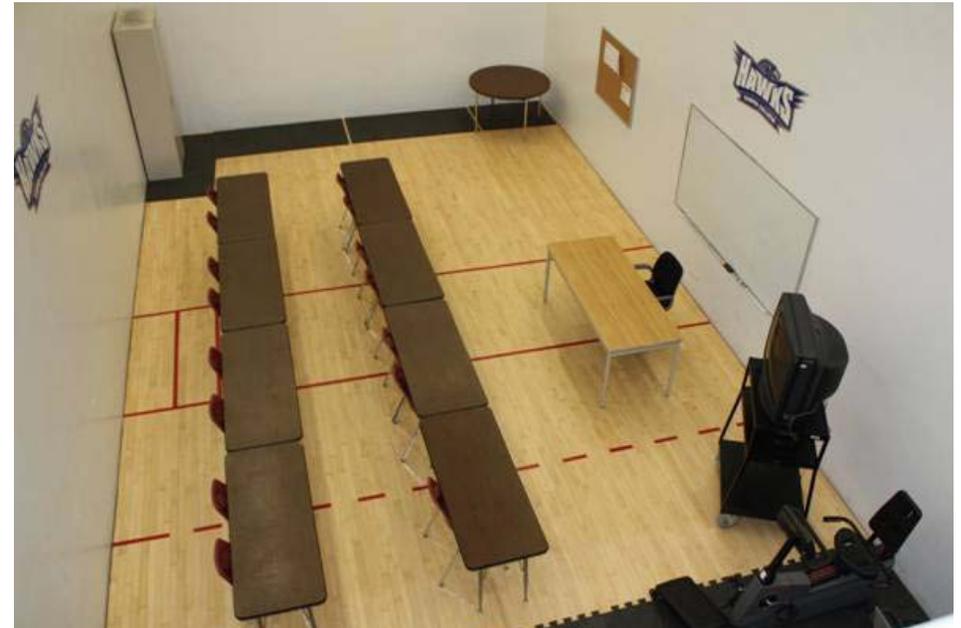
Building M houses physical fitness, sports, wellness, classrooms, and offices. The building's large spaces, such as the swimming pool and gymnasium, are well suited for their use and are in generally good condition. The support spaces, such as the locker rooms, training areas, offices, classrooms, fitness rooms, wrestling room, toilets,

and gathering areas, are all in original condition and need updating. The original squash and racquetball courts have been converted to inadequate classrooms, storage and training rooms.

The mechanical, electrical, plumbing, and fire protection systems are all original and in need of significant upgrades.

Handicapped accessibility is very poor throughout the building, and there is a lower exterior entrance which is difficult to maintain in the winter due to snow and ice.

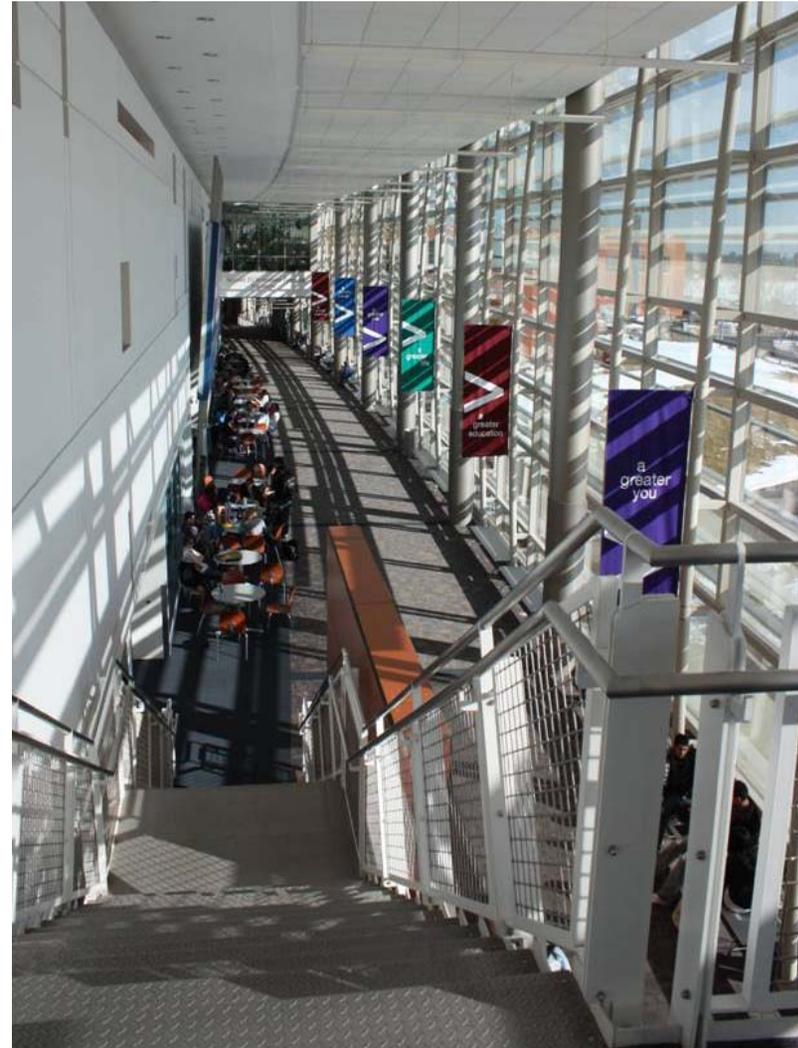
Building X

All systems are up-to-date and in very good condition. The building is fully accessible, and fire protection and sprinkler systems are adequate.

The building does not have a freight

elevator, and access from the loading dock to upper floors can be difficult.

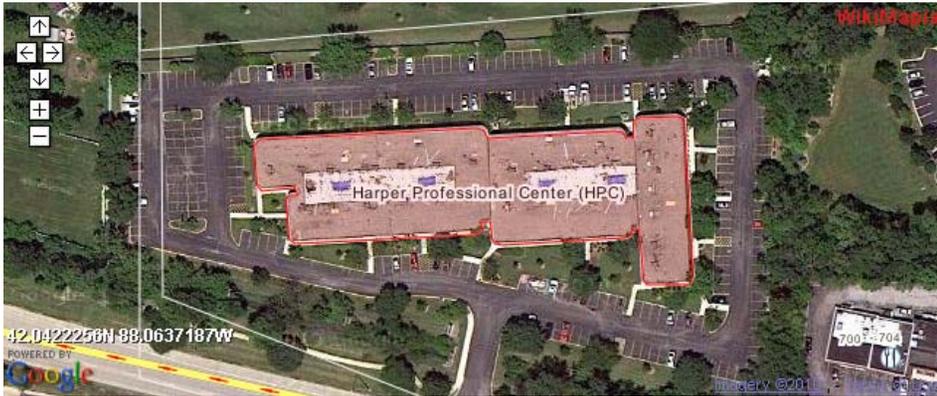
Harper Professional Center building aerial

The building has had a new roof and HVAC system upgrades recently.

The building suffers from poor utilization during the daytime given its program focus of adult population. The building could function better with an improved entrance and vestibule area.

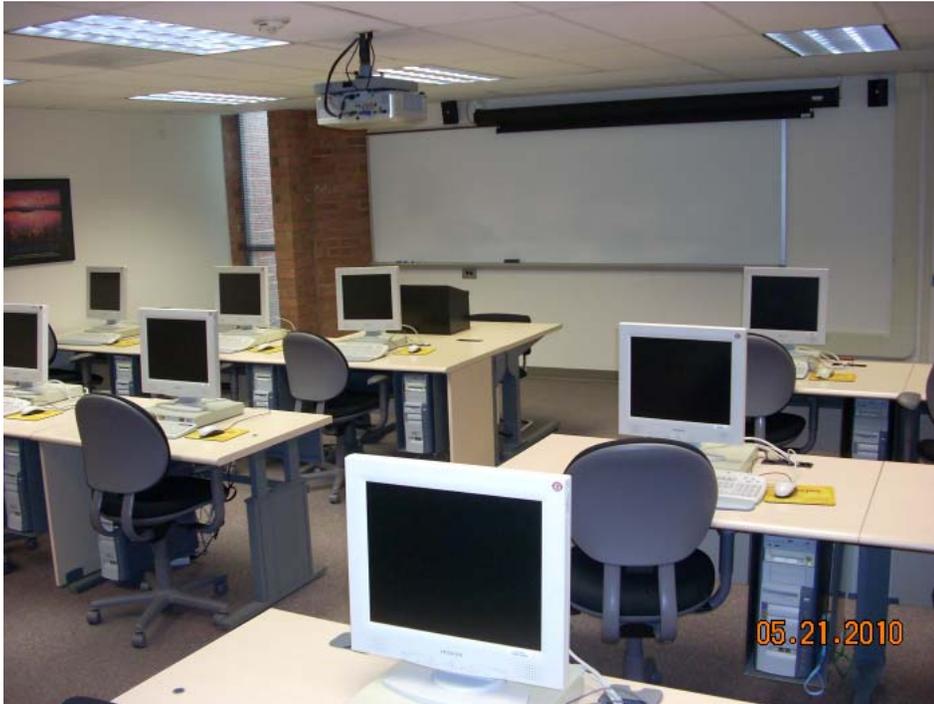
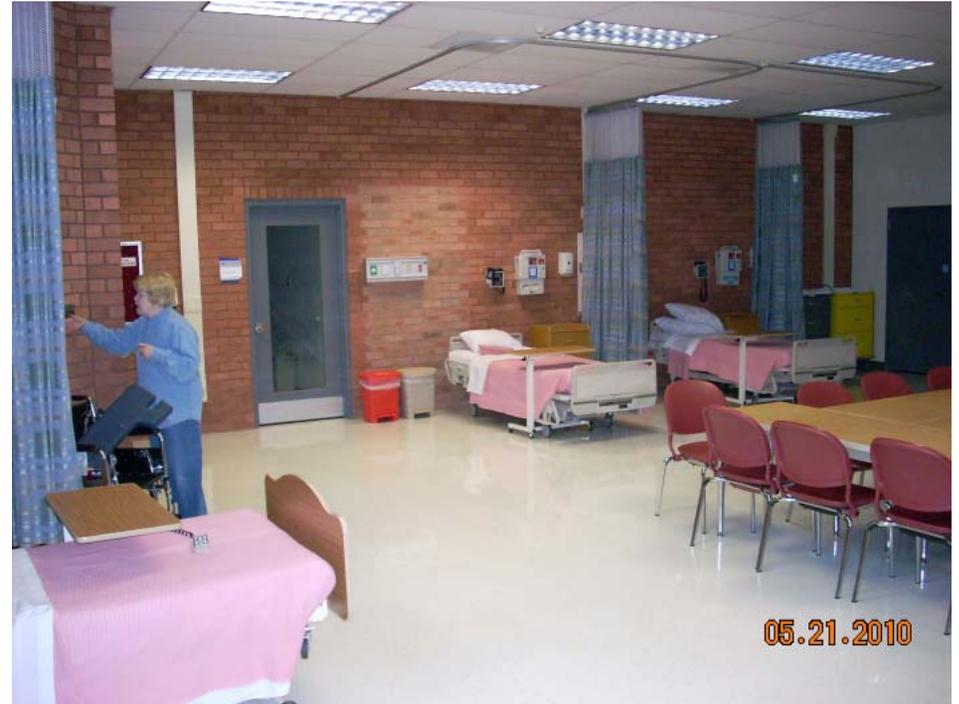
The NEC computer lab

The building is well maintained, but signs of a recent roof leak indicate the need for a roof replacement. The HVAC

and all other systems are original and could use upgrades.

Overall, the building does not present an image of a collegiate environment and is not in keeping with the main Harper campus. Upgrades to the entry, study areas, support, and library would

give the building a better ambiance and encourage students to take further advantage of the courses offered on the main campus.
