3. Existing Buildings

Existing Building Assessment

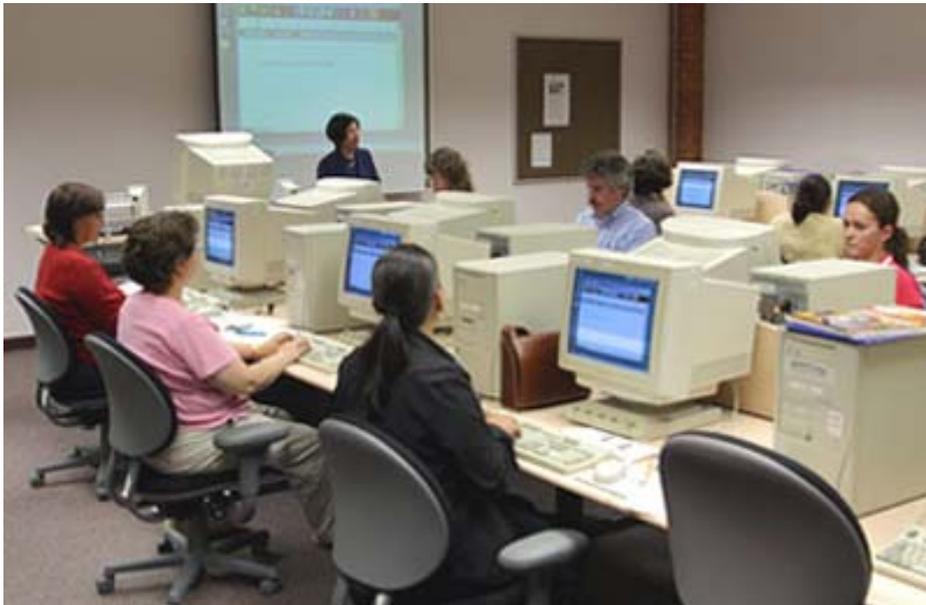
HPC computer lab

All systems are up-to-date and in very good condition. The building is fully accessible, and fire protection and sprinkler systems are adequate. The building was designed with a “pharmacy industry standard” ventilation system in the laboratories. This system ventilates the rooms 24/7 and therefore requires a large amount of energy to heat and cool the spaces. This system should be investigated and modified.
